# Summary of EPA Surface Water Sampling of Select Metals Results to Date

Gold King Mine Blowout

August 7, 2015

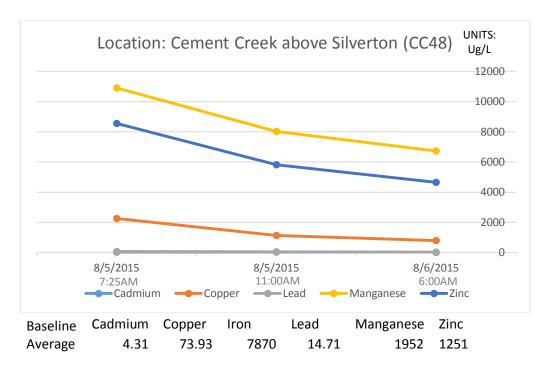
The first graph provides data on Cement Creek, the downstream from the blowout (CC48). Concentrations throughout the first day following the blowout are above historical averages for the copper, lead and manganese. However, the graphs demonstrate a decrease in those concentrations over the 24 hour period.

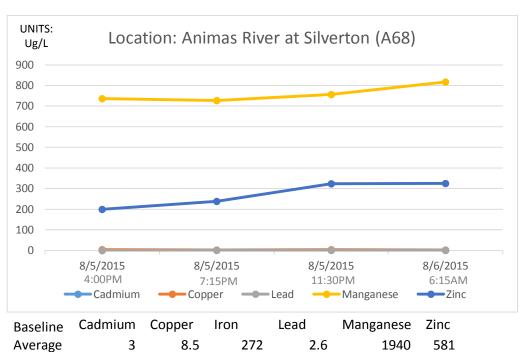
The second graph provides data on the Animas River above the town of Silverton (A68) and above Cement Creek. This graph demonstrates relatively unchanging metals concentrations that are at or below historical averages.

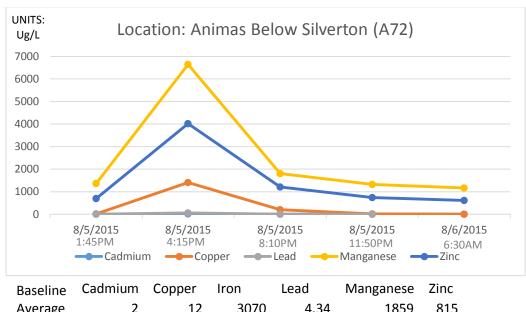
The third graph demonstrates the data from the Animas River just below the town of Silverton (A72). The graph shows an initial spike in metals concentrations with levels returning to historical averages by the morning of August 6, 2015.

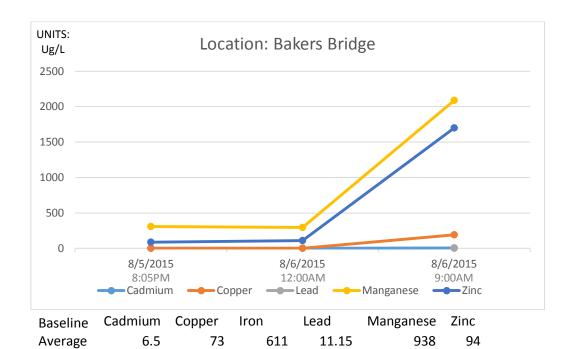
The fourth graph demonstrates the data from Bakers Bridge on the Animas River just above Durango, CO. Since this location is about 20 miles from Silverton, the metals concentrations are

increasing above historical averages. But, it is believed that subsequent data collection activities will demonstrate a decrease in concentrations similar to those seen at upstream locations.

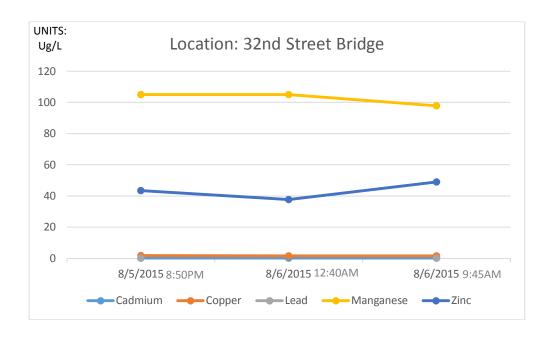
The fifth graph is of the 32<sup>nd</sup> Street Bridge sampling location. At the time the samples were collected, it does not appear that the contamination had yet reached this sampling location.
